Inspection Report – Barn at Tristan farm, Red Lane, Bordon, GU35 8SR

Task: To inspect and report on the suitability of the barn for conversion to residential use.

Inspection: The property was inspected by Mr Elvin Gomery BEng on 20 January 2023.

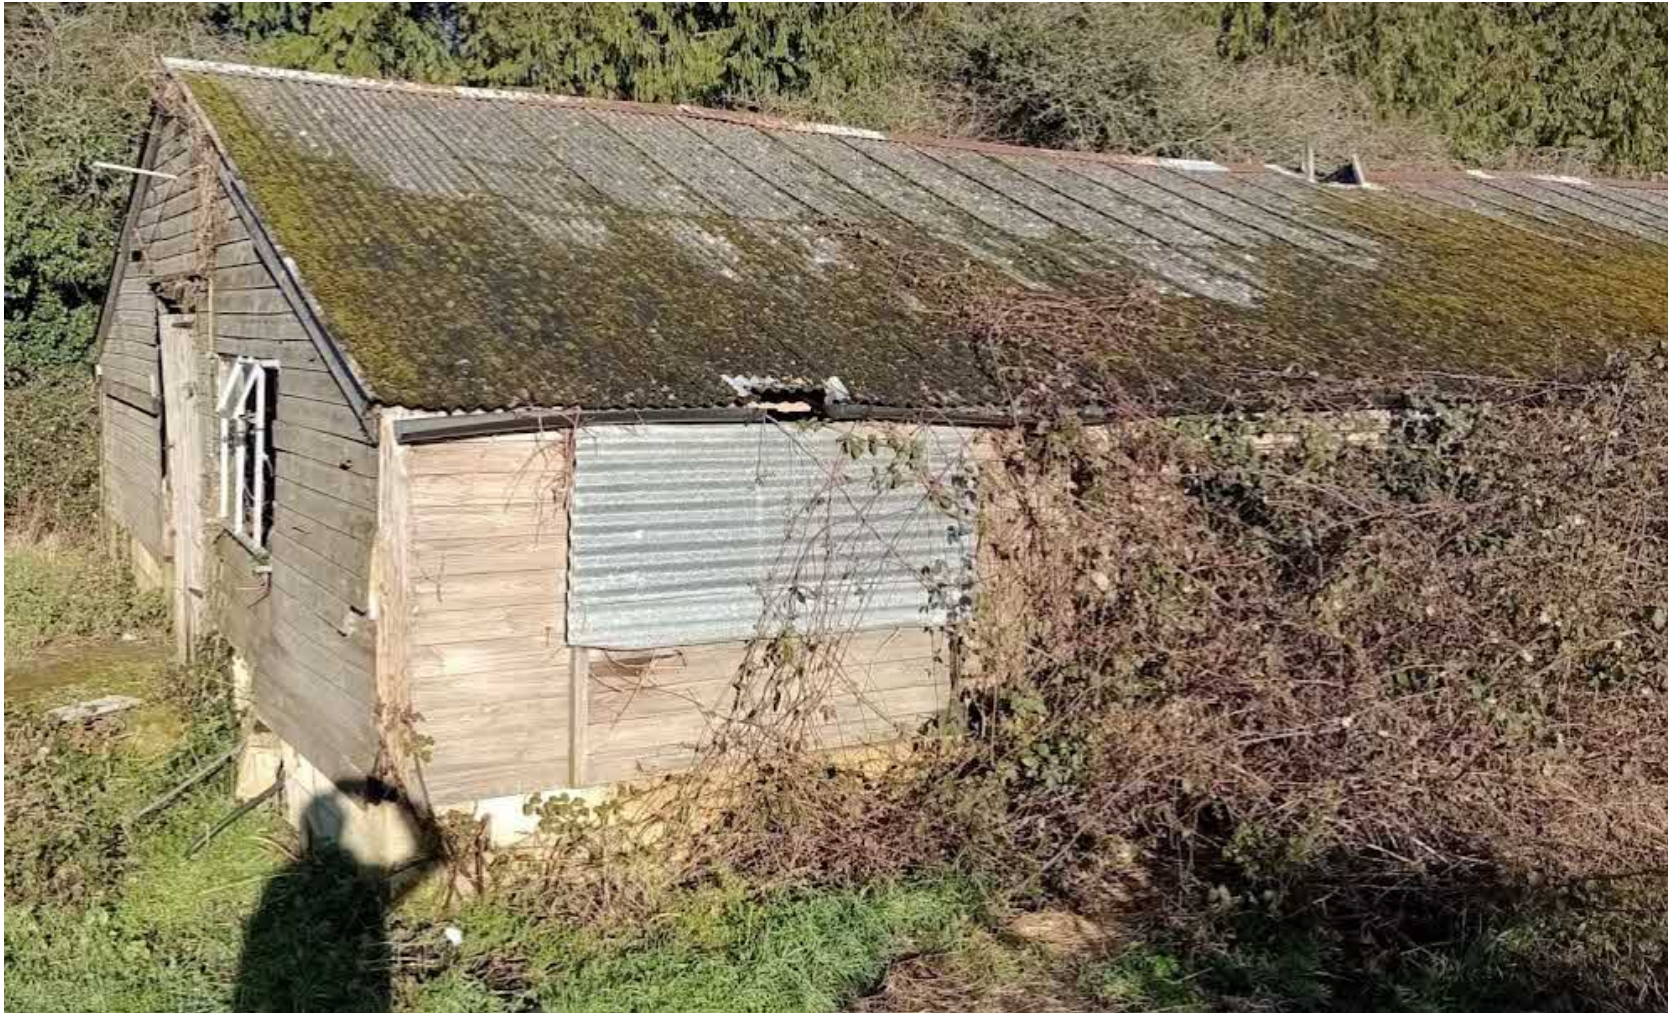
External blockwork lower walls and timebr clad timber external walls and metal sheeting roof (Front and side wall)

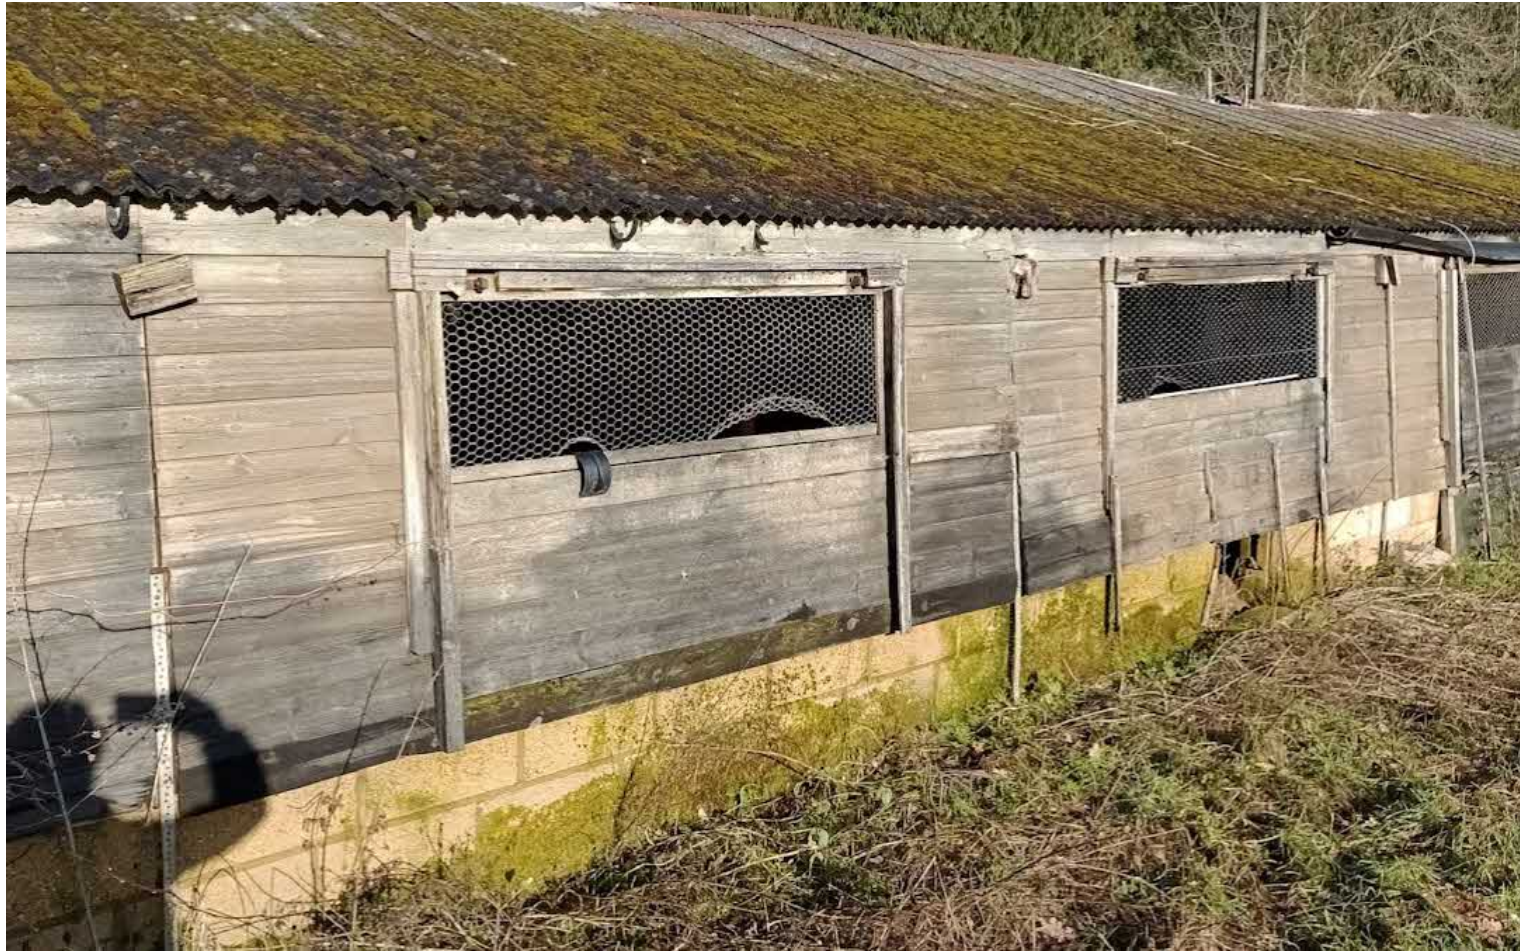
External blockwork lower walls and timebr clad timber external walls and metal sheeting roof (Side wall)

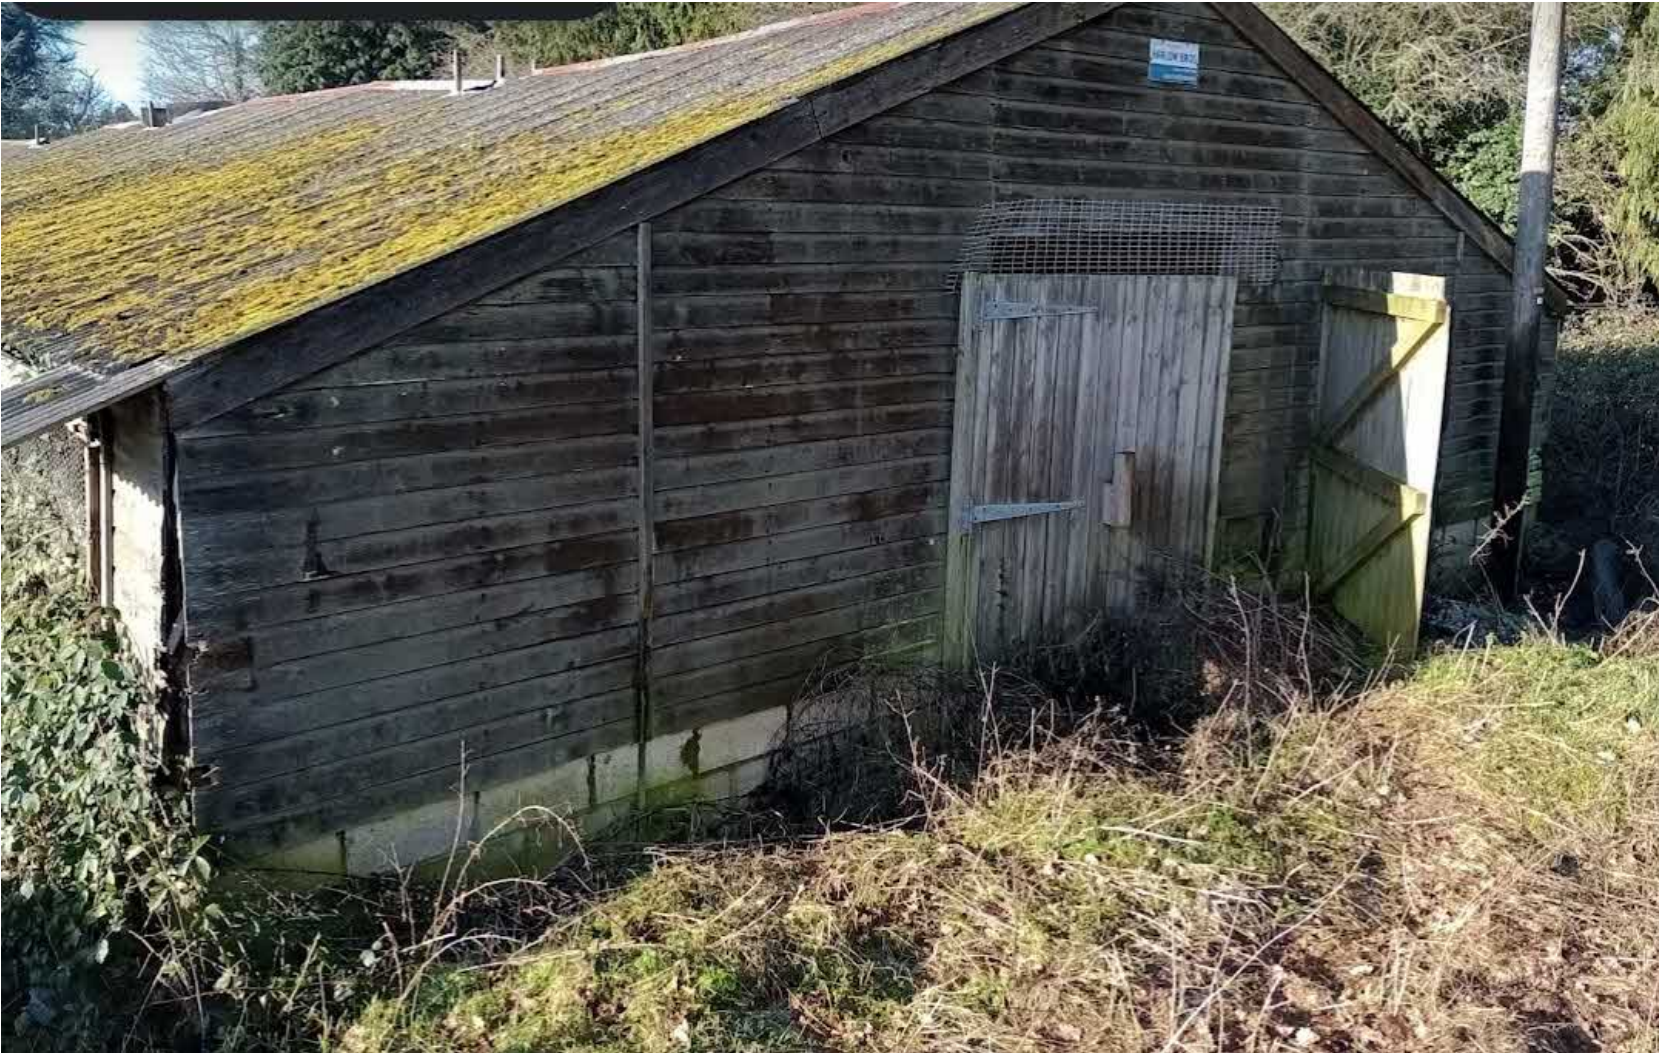
External blockwork lower walls and timebr clad timber external walls and metal sheeting roof (Rear wall)

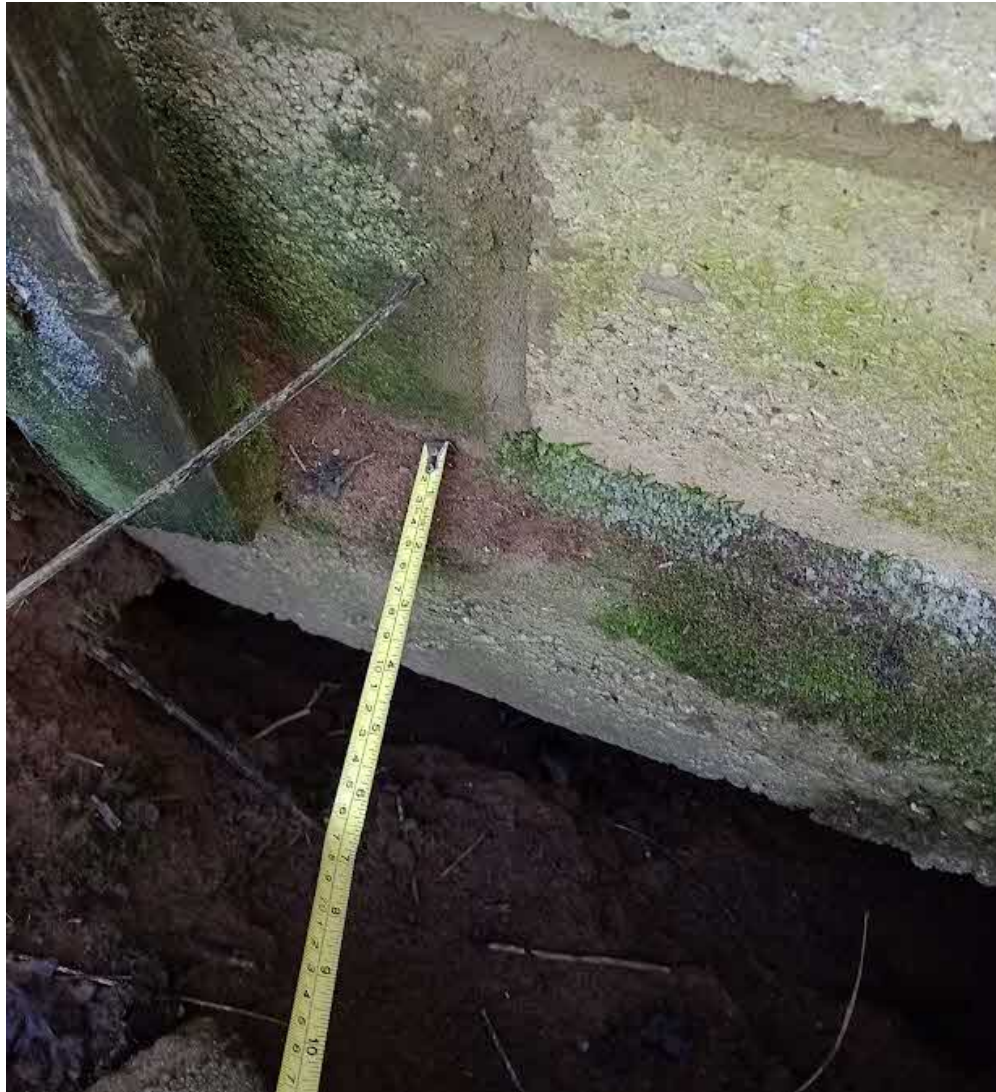
Foundations and ground floor slabs: There were some holes excavated on site, these were used to find the existing foundation build up. It was found that the foundations are concrete and extend approximately 0.5m below existing ground level and the concrete foundations are approximately 200mm thick. There are also ground bearing slabs internally which also appear to be 200mm thk. The soil was observed to be very dry and sandy. There appear to be some animal holes/burrows under the foundations and slabs and in some areas these burrows have undermined the foundations and slabs. In these areas the foundation/slabs will need to be underpinned to ensure adequate bearing on the soil beneath.

Concrete foundations revealed in hole on site, 200mm thk concrete

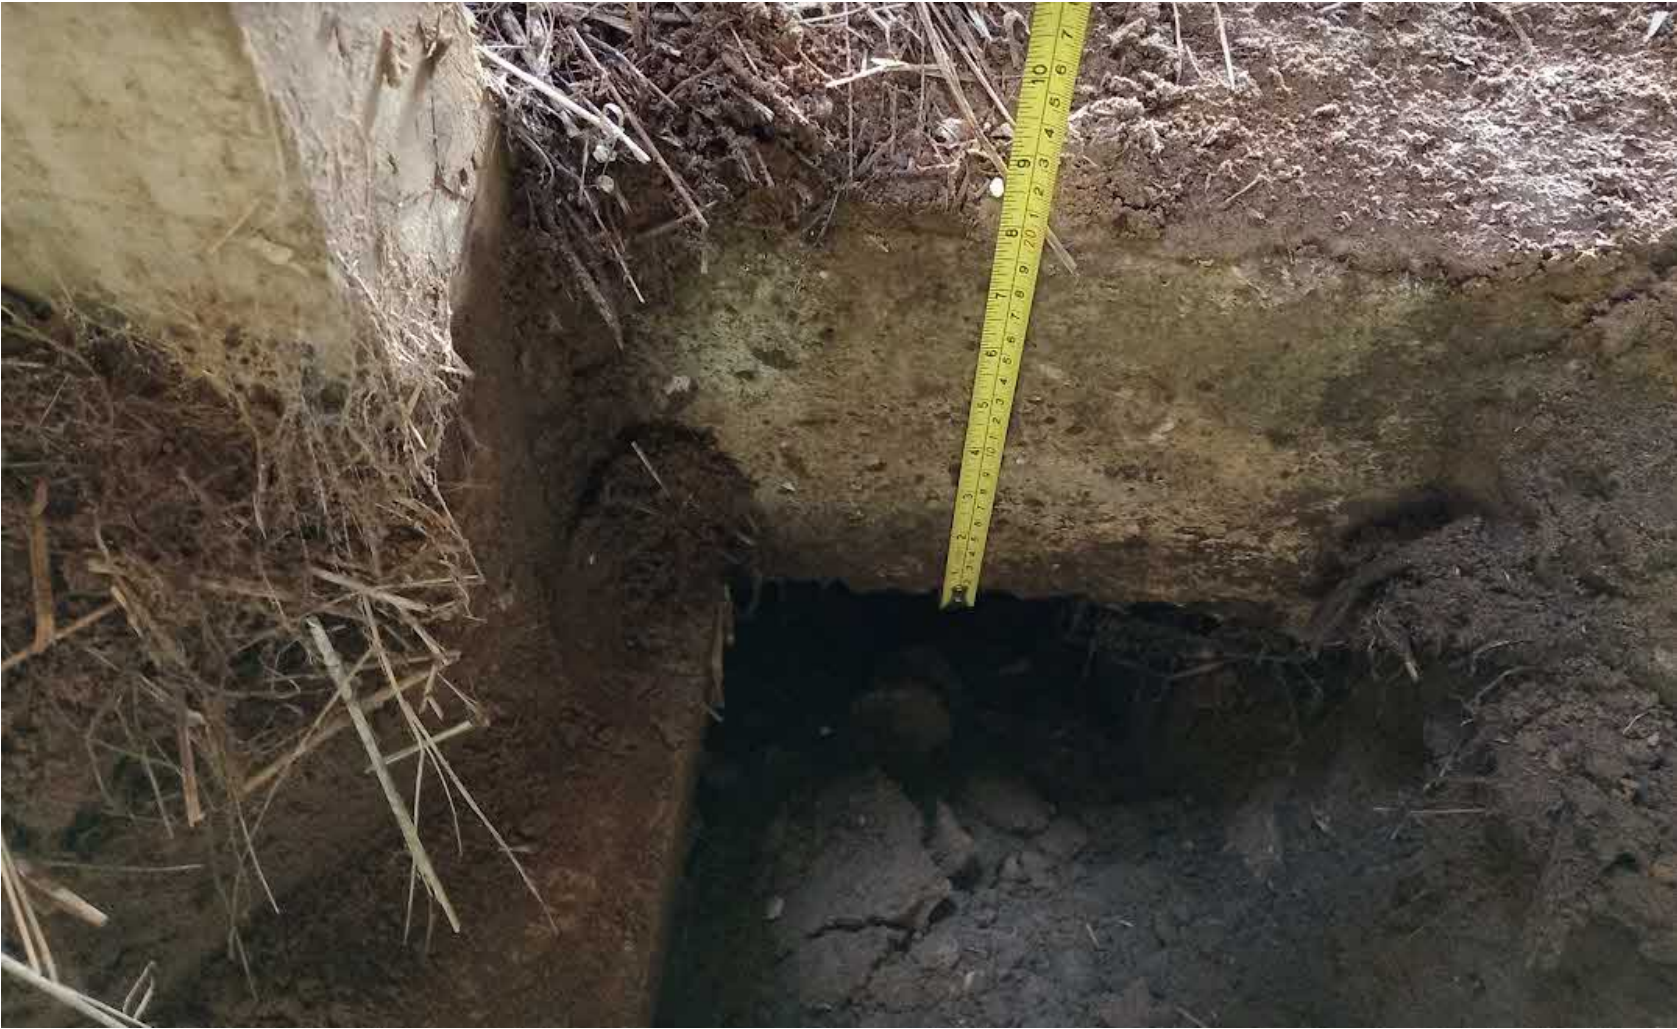
Ground Floor: The ground floor appears to be of solid, concrete construction in most areas and found to be ground-bearing and appears to be in a generally satisfactory condition. There are some areas where the slab has been undermined by the animal burrows and these areas will need to be repaired

Concrete ground floor slab revealed in hole, 200mm thk

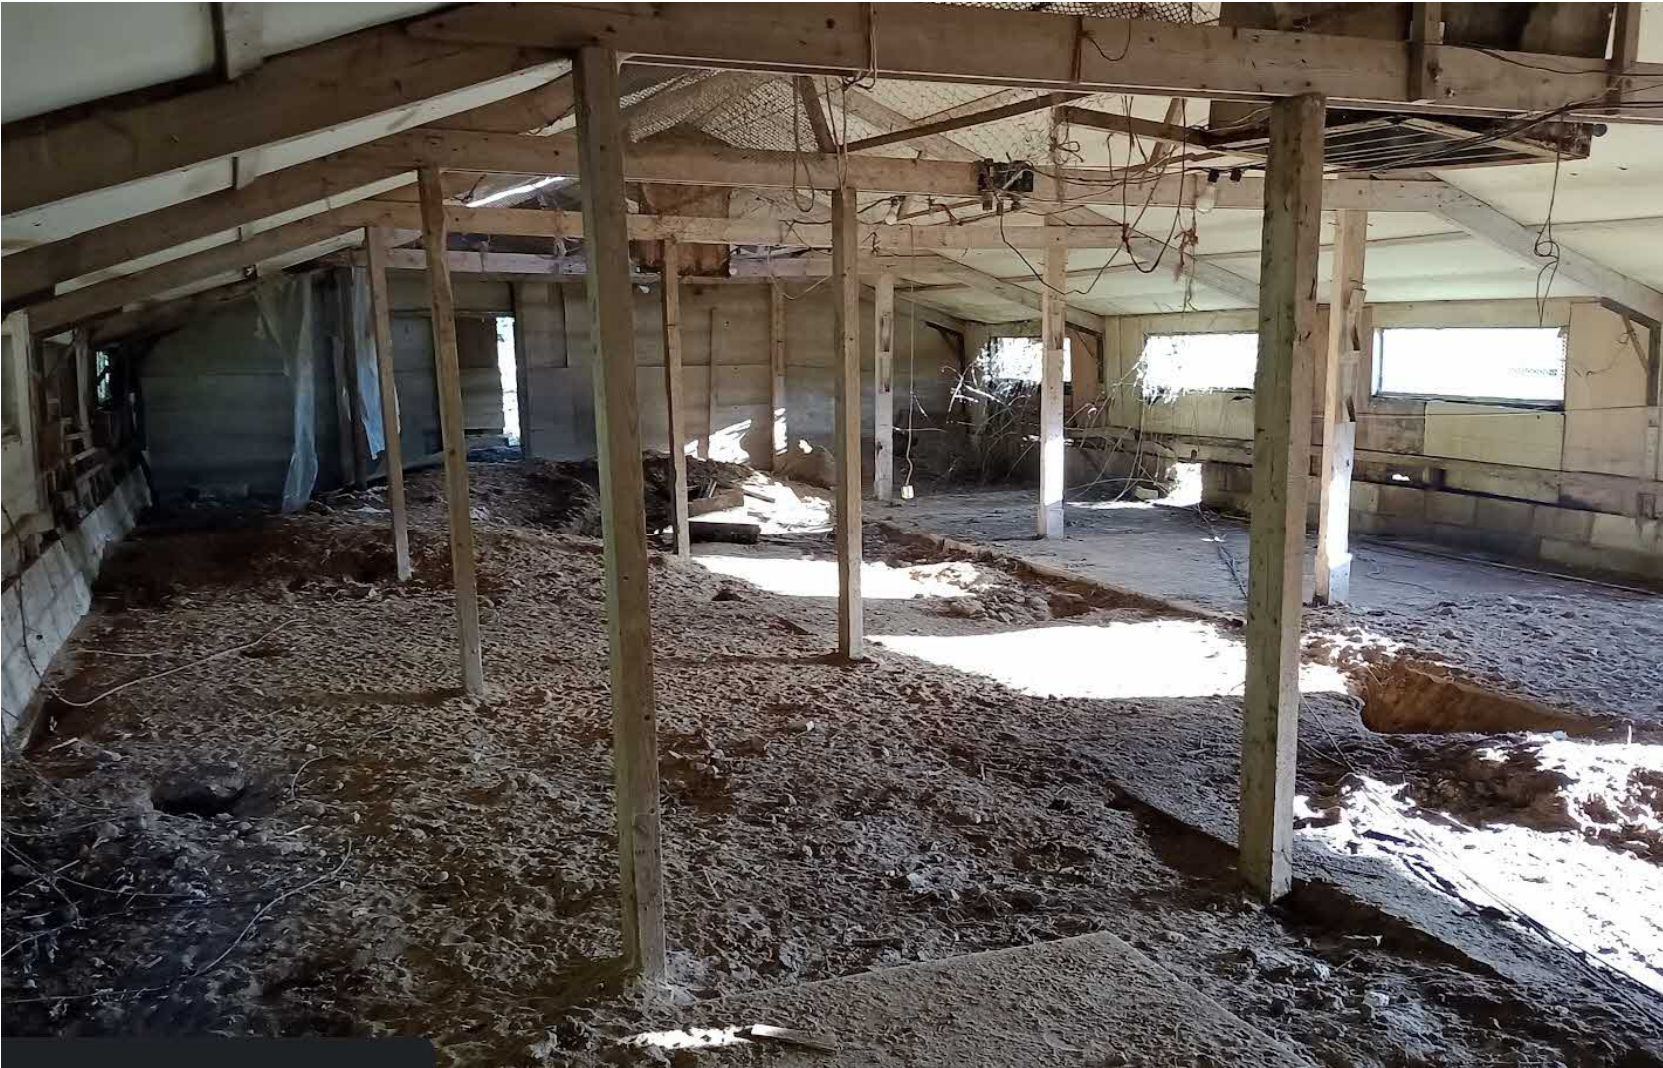
Roof Structure: The roof structure is supported on timber purlins which appeared in sound condition. These purlins are in turn supported on timber trusses spanning between the external walls and internal timber posts. The majority of the timber work appeared sound, however some posts were noted to have rotted at the ground slab supporting level and some rafters beginning to rot were supported on the external walls. These timber members were beginning to rot and will need to be repaired as part of any renovation works.

Internal view of barn showing roof trusses and internal floor slabs and posts

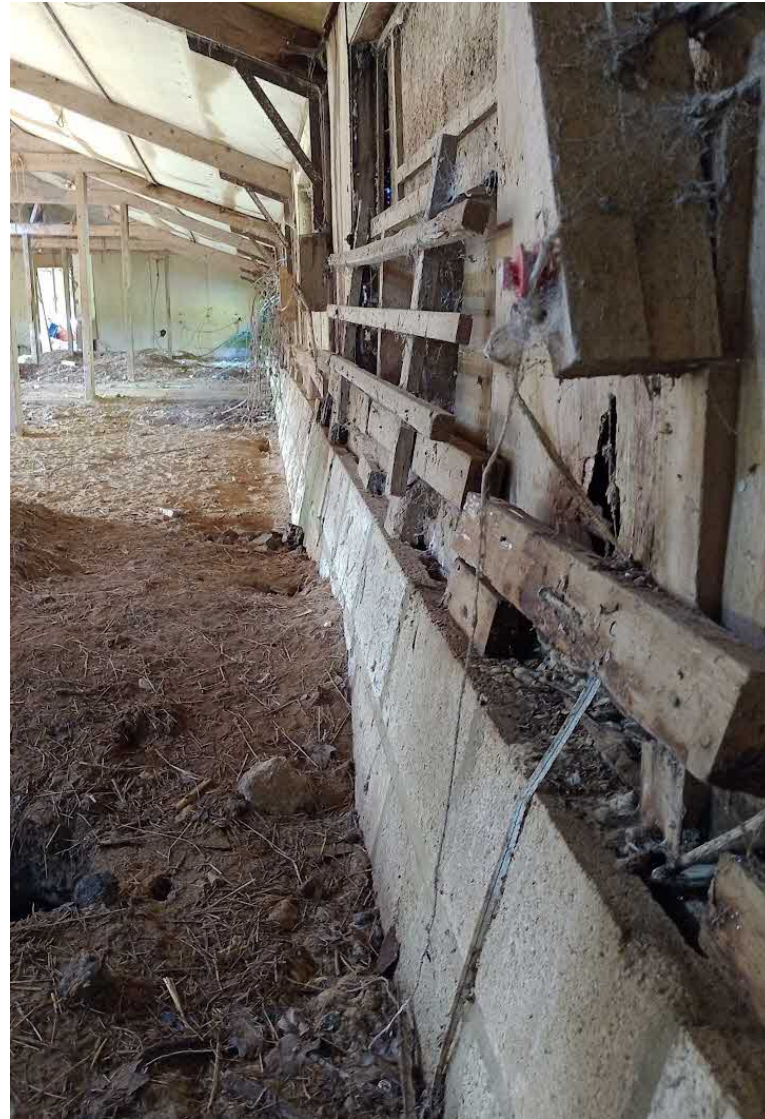
External walls: One of the external side walls is leaning outwards, probably due to foundation settlement possibly due to the underground burrows. This wall will need to be rebuilt and existing foundations underpinned as required.

Leaning side wall needs to be re-built

renovation works proposed for the building. We would therefore recommend that the roof cladding is replaced with a similar composite profiled insulated steel sheet cladding than the original and that any damaged elements of roof purlins, rafters, studs and eaves plate are repaired locally. The leaning external wall will also need repair.

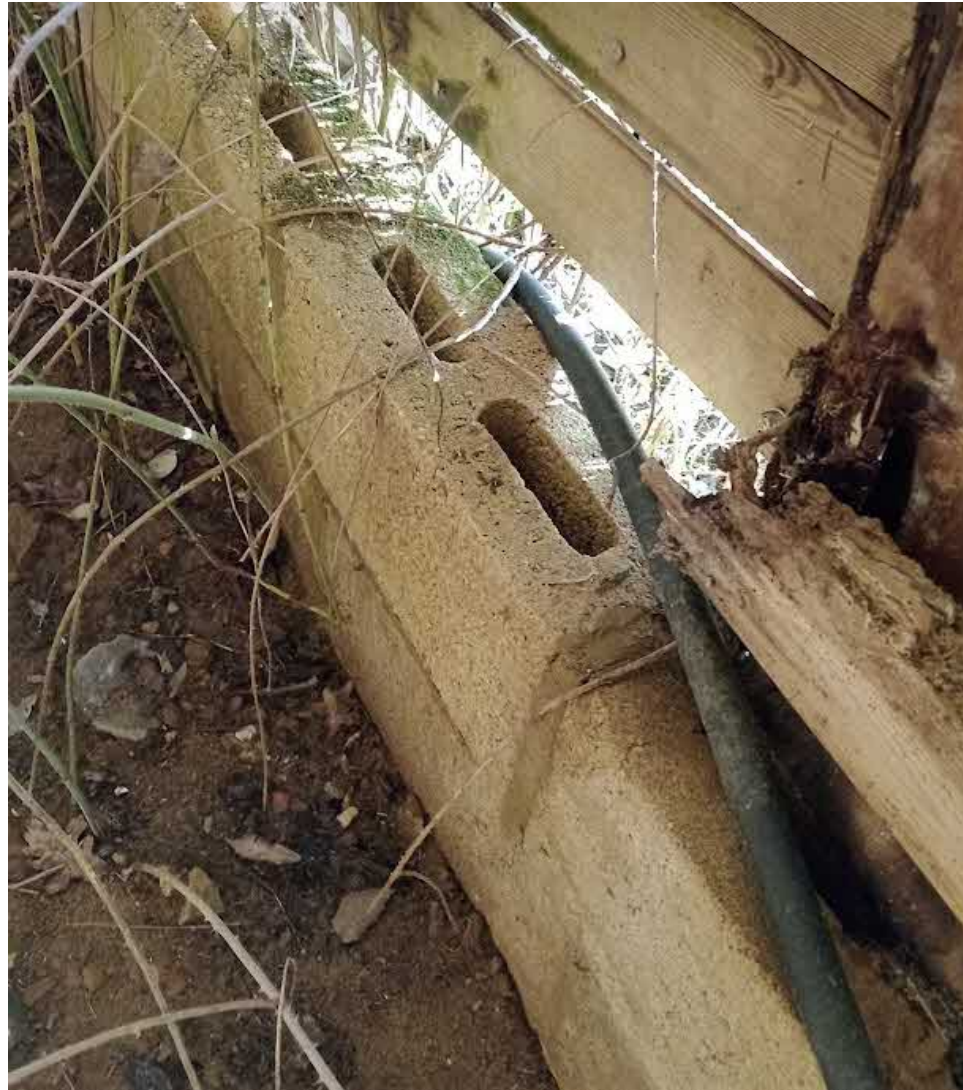
External lower hollow blockwork wall (140mm thk)

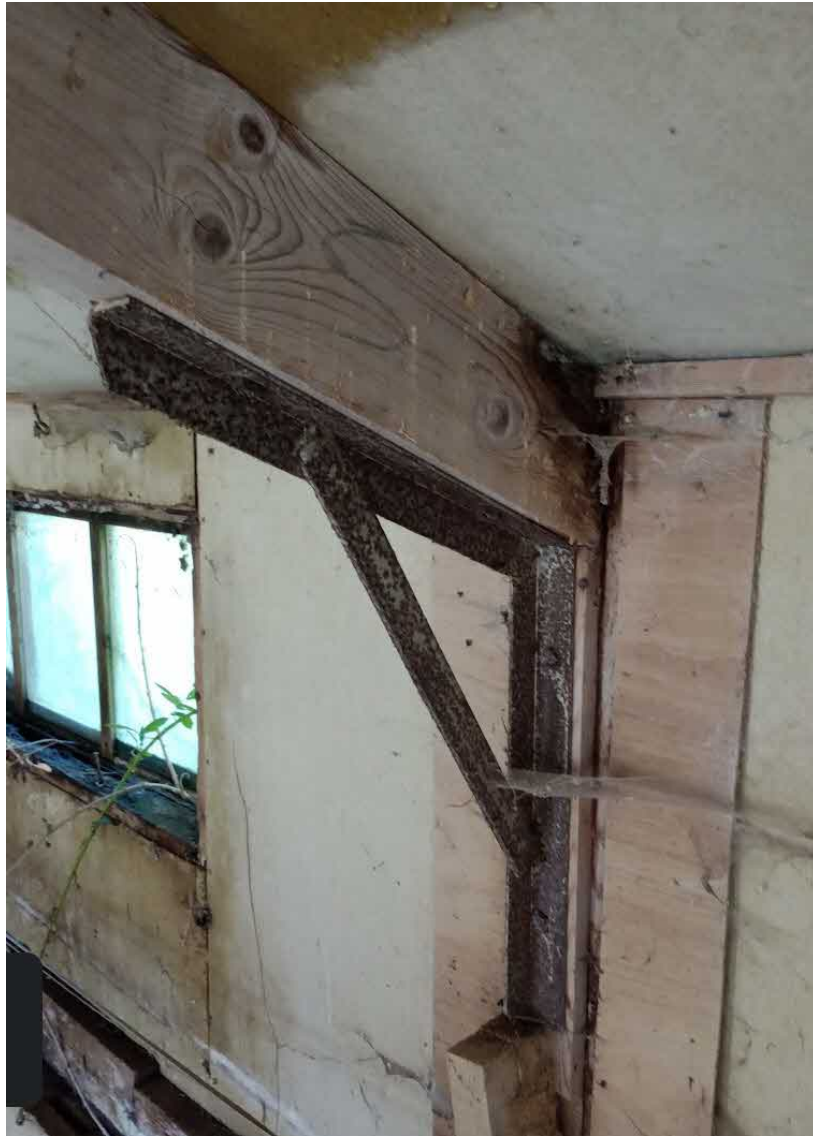
Steelwork truss eaves connection detail

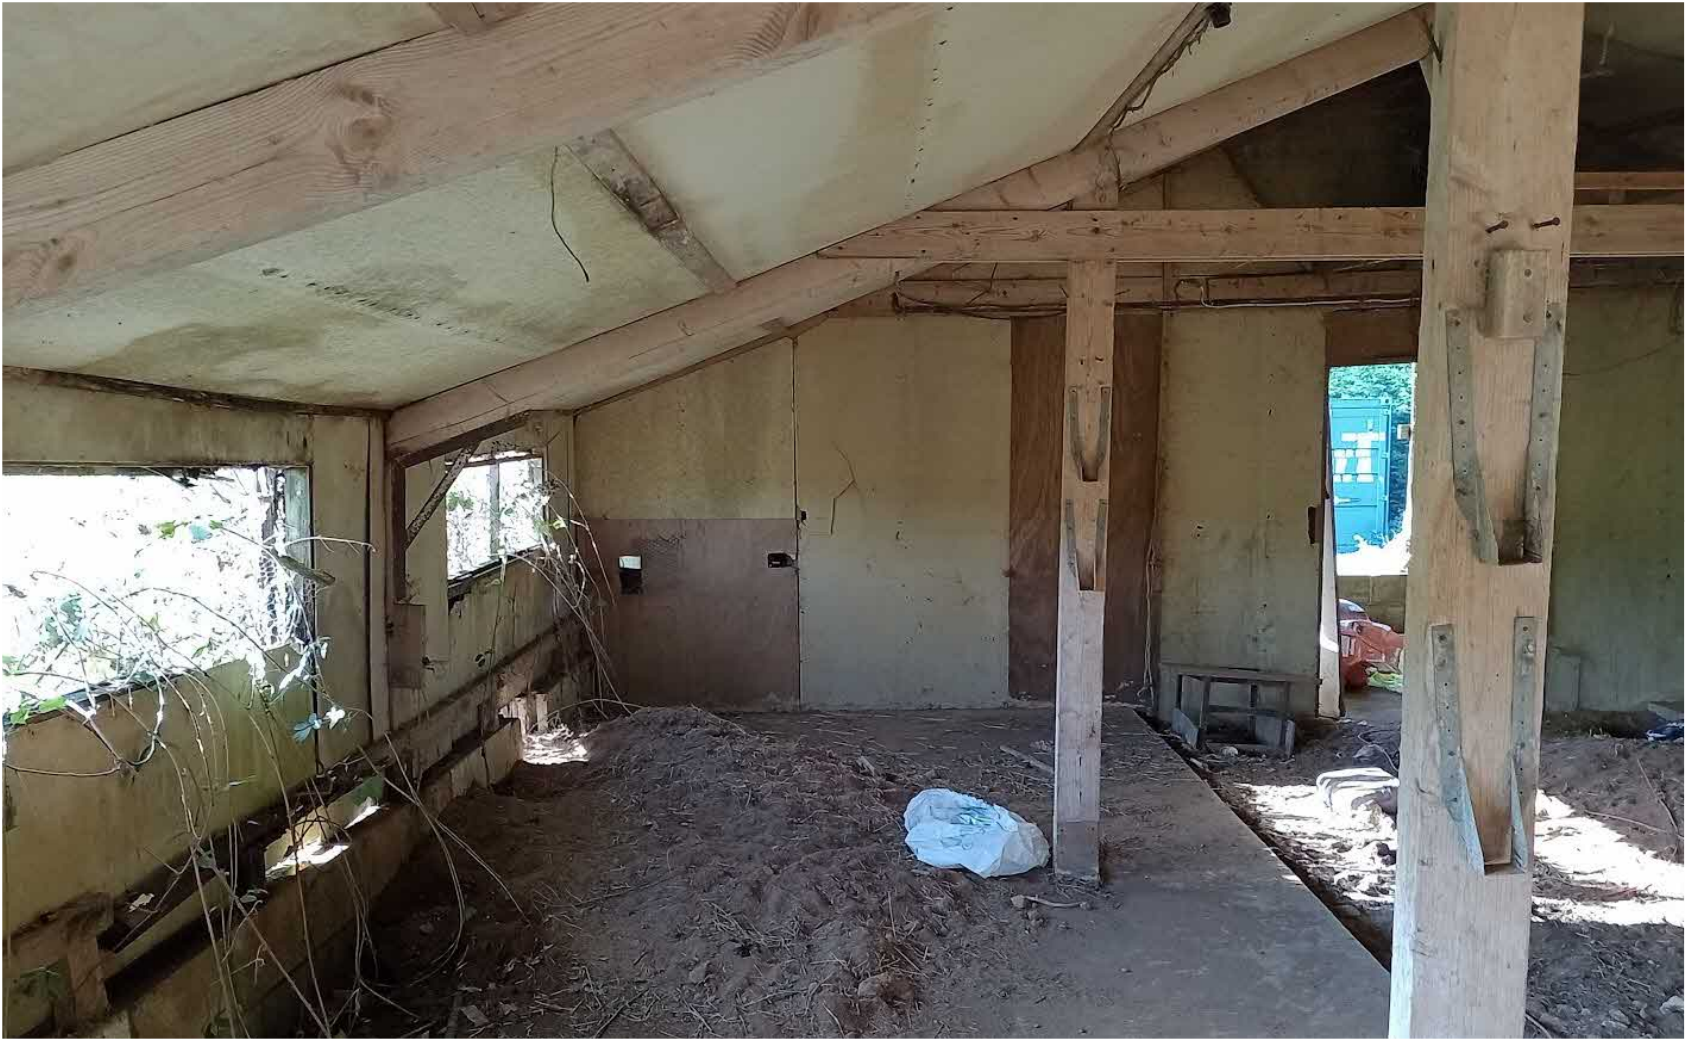
Timber roof trusses and posts supported on slabs
